CERTIFICATE OF APPROPRIATENESS**Application Date:** June 28, 2016**Applicant:** Phil Arnett for 2315 Union Street, LLC, owner**Property:** 2315 Union Street, Lot 11, Block 384, Baker W R NSBB Subdivision. The property includes a historic 900 square foot, one-story wood frame single-family residence situated on a 5,000 square foot (50' x 100') interior lot.**Significance:** Contributing residence, located in the Old Sixth Ward Historic District.**Proposal:** Alteration – *Revision. The applicant has removed the original decorative gable trim, gable window, and window trim without a COA. This action was outside the scope of work approved in four earlier COAs for this remodel, and was done without staff knowledge or prior HAHC approval.*

The applicant is now requesting approval for the installation of an appropriate salvaged wood 6-over-6 gable window, the reinstallation of the original wood window trim, and the installation of reproduction wood decorative gable trim that matches the original

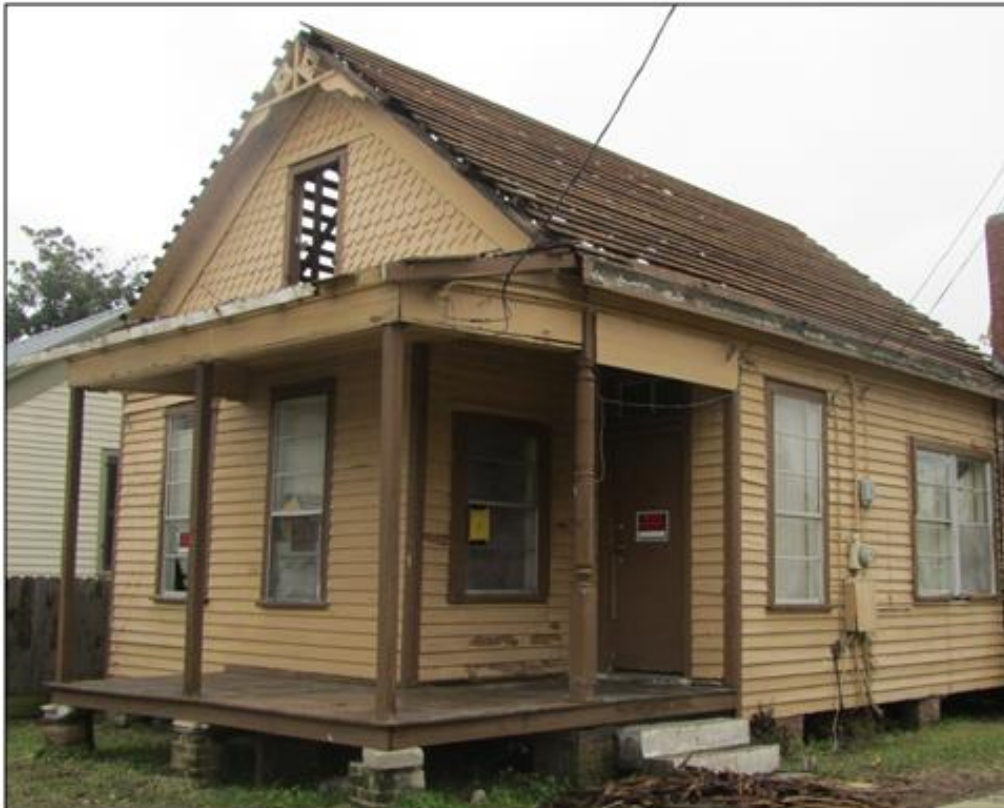
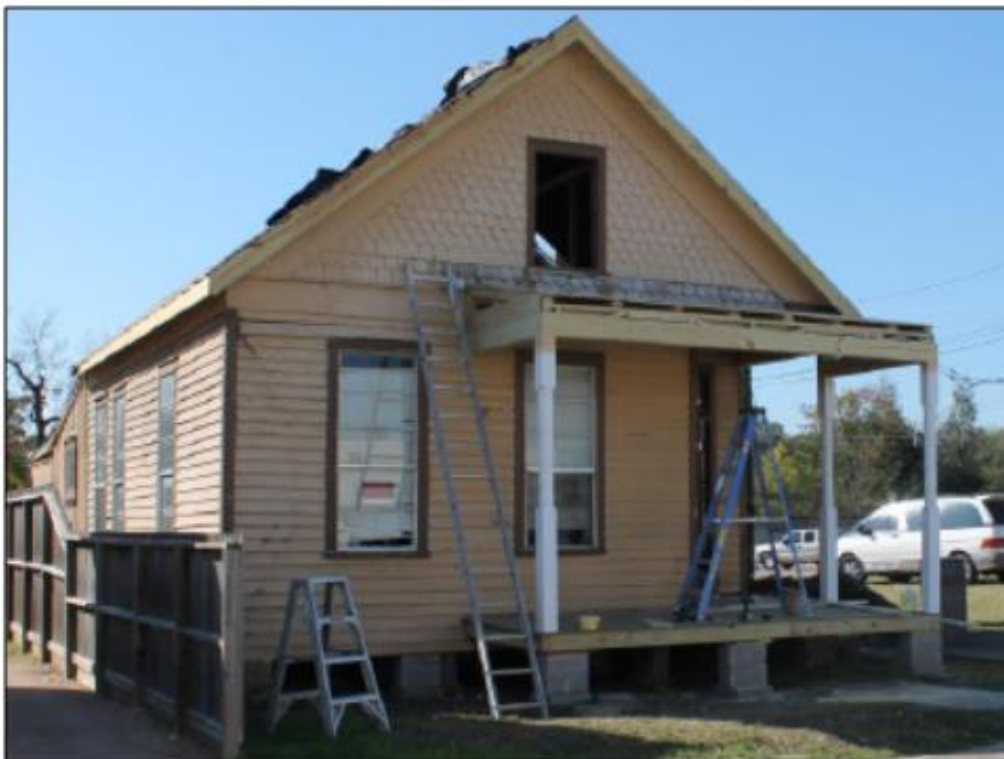
PHOTOS OF RENOVATED GABLE WINDOW / TRIM

- In March 2016, the applicant installed a 4-over-4 window in the gable; this window did not match the original 6-over-6 window, nor was it approved for replacement

- In May 2016, it was brought to the attention of staff that the original decorative trim had been removed at an unknown date after the current owner had purchased the property; the owner indicated it was destroyed while pressure washing the house

- On May 10, 2016, staff contacted the applicant and instructed him to apply to the HAHC for the outstanding issues with the structure, including: the destroyed decorative gable trim, the replaced gable window, and removal of the trim around all the original window openings

In addition to any other remedies that HAHC sees fit to require, staff recommends a Certificate of Remediation for the removal of the decorative gable trim, gable window, and window trim. Since the historic decorative gable trim and gable window have been destroyed by the applicant and these actions therefore cannot be reversed, a Certificate of Remediation will allow the project to progress without the Commission approving the unauthorized removal materials or deeming the unauthorized work appropriate.

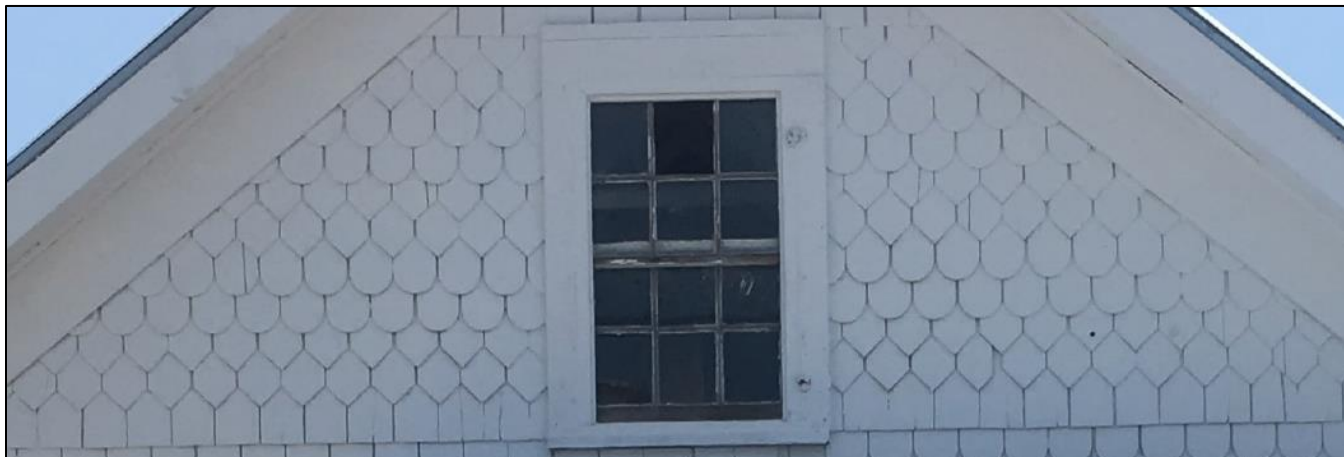
PROPOSED SALVAGED GABLE WINDOW

Windows/Doors: The existing 6-over-6 gable window was removed during an earlier phase of construction. The applicant proposes to install a salvaged 6-over-6 wood window to match the original size and design. See photo for more detail.

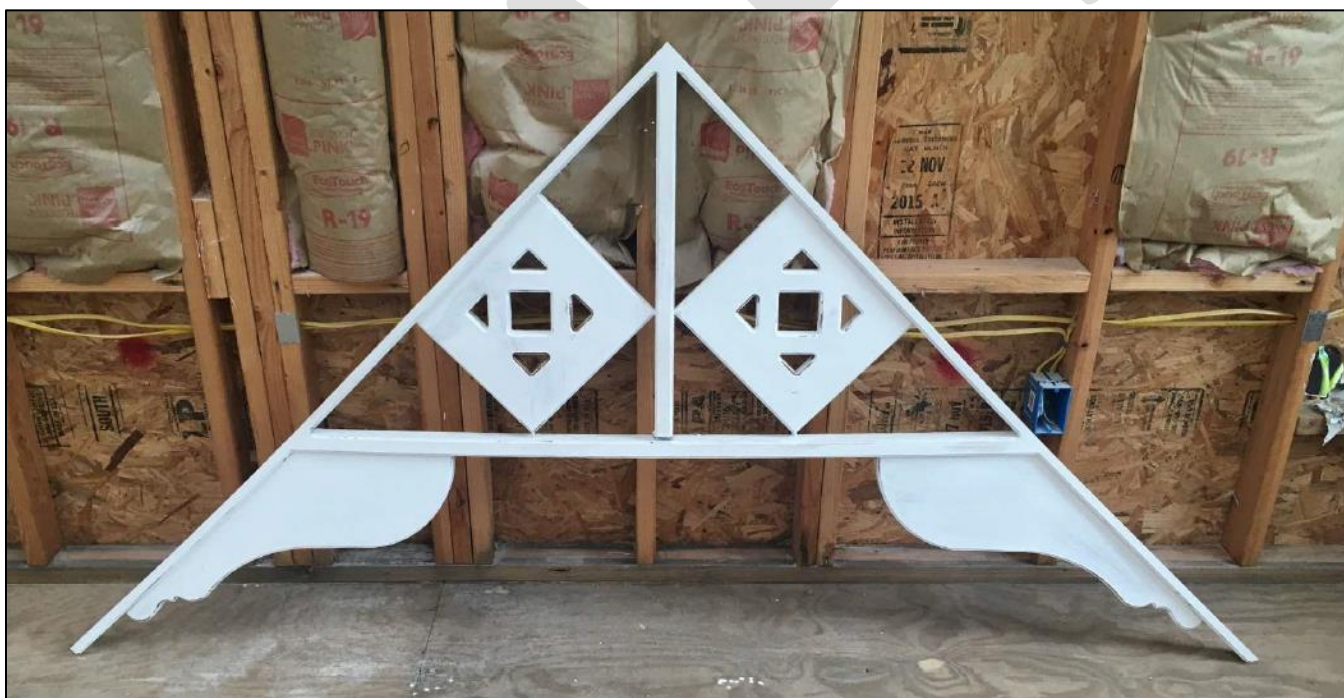
PROPOSED RECREATED WOOD DECORATIVE GABLE TRIM

Exterior Materials: The original decorative wood gable trim was destroyed when the house was power washed. The applicant ordered a custom milled wood replica of the original trim to be installed. All existing window trim will be reinstalled. See photo for more detail.

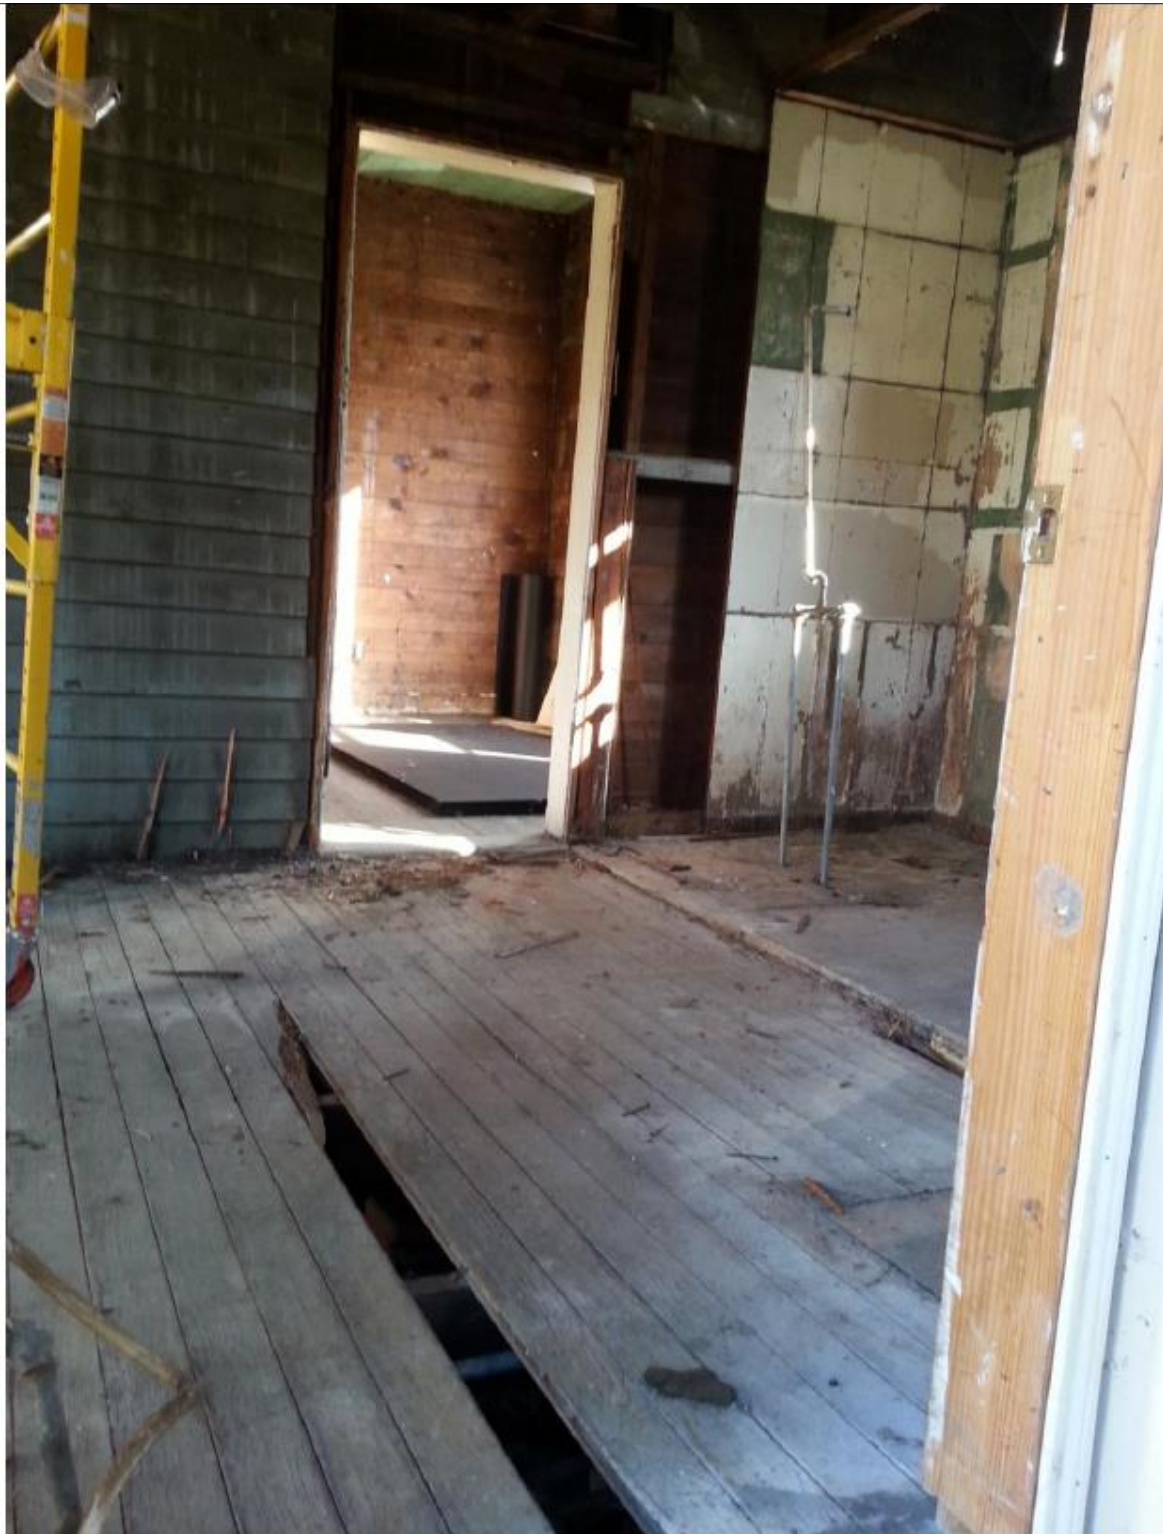
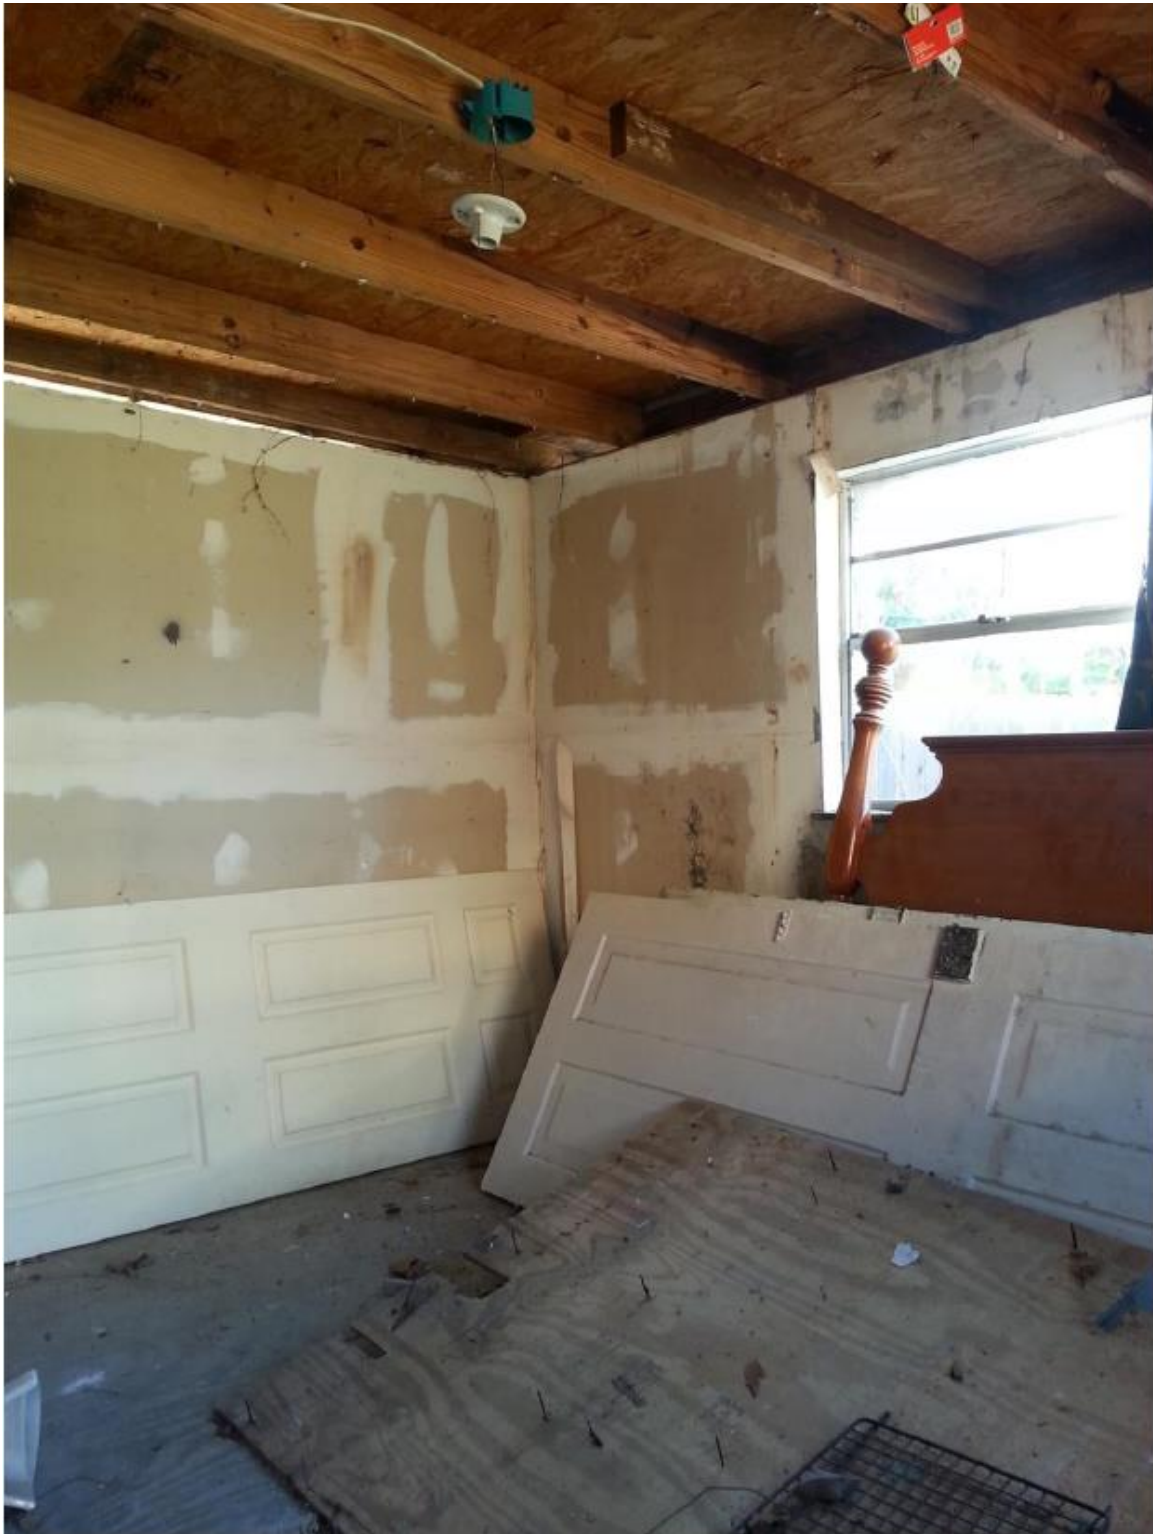
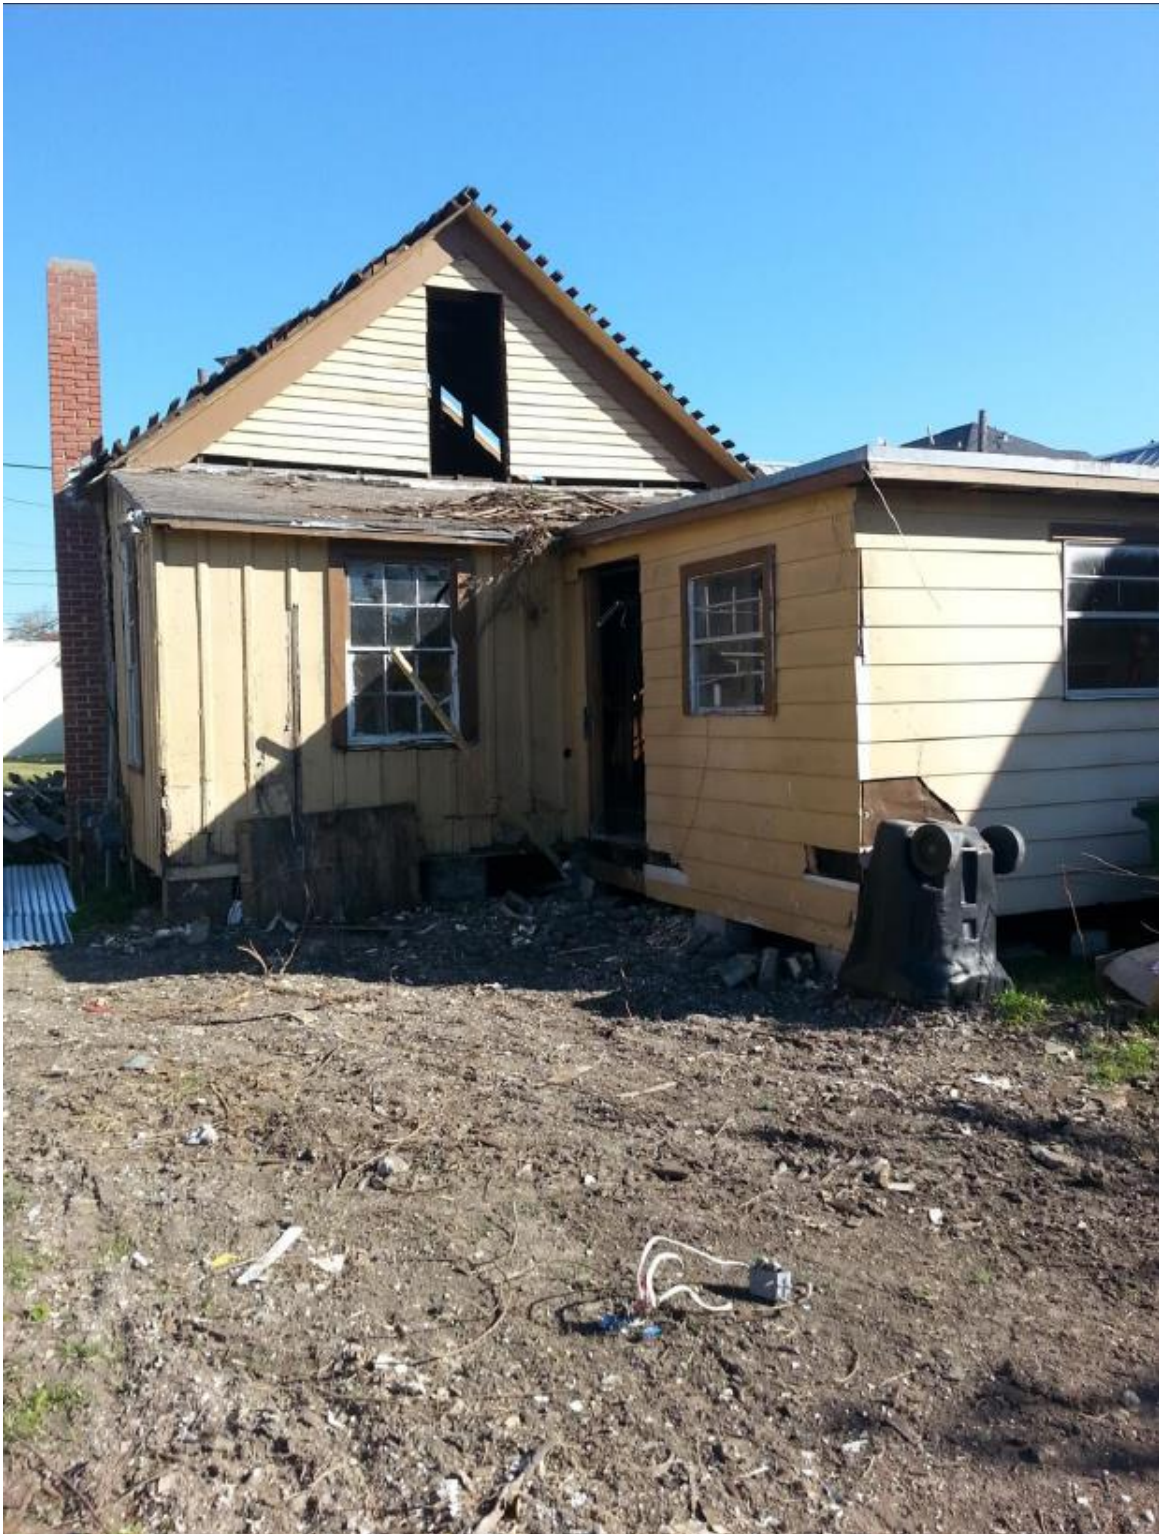
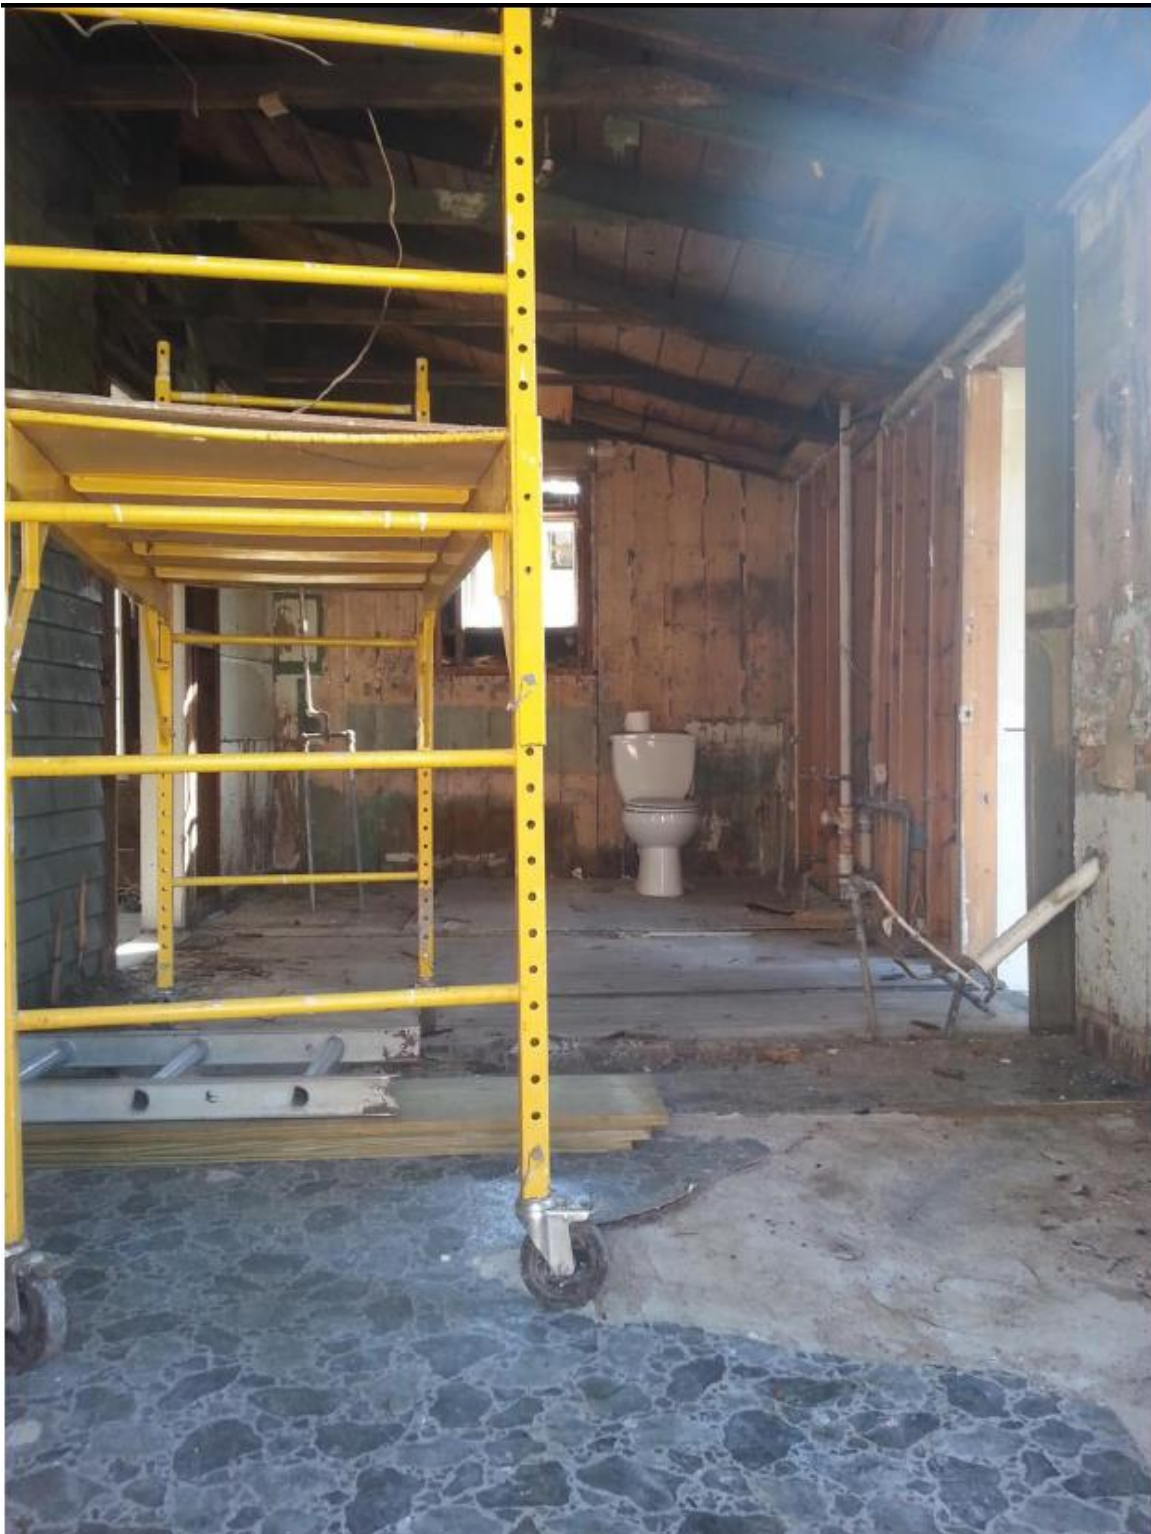
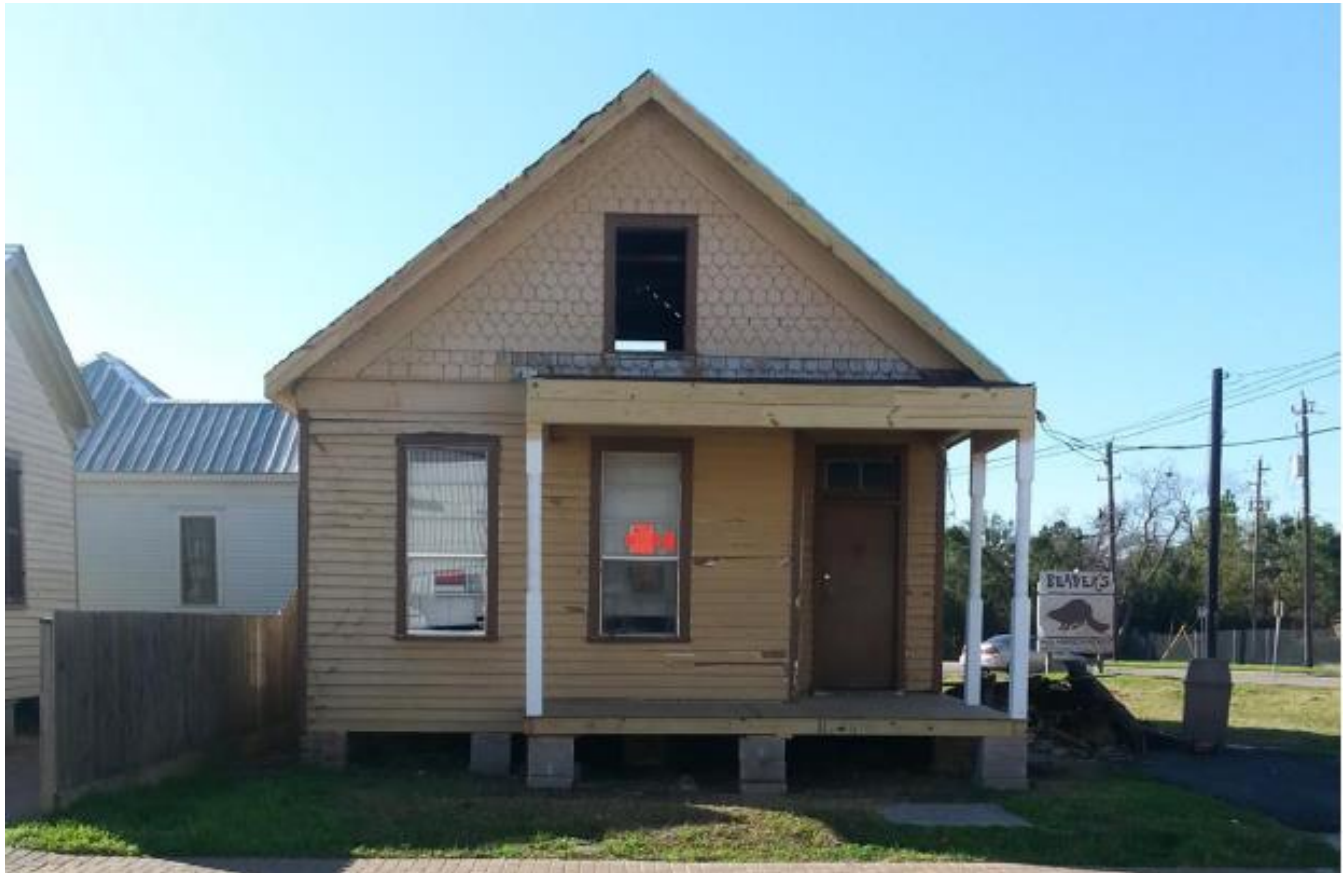
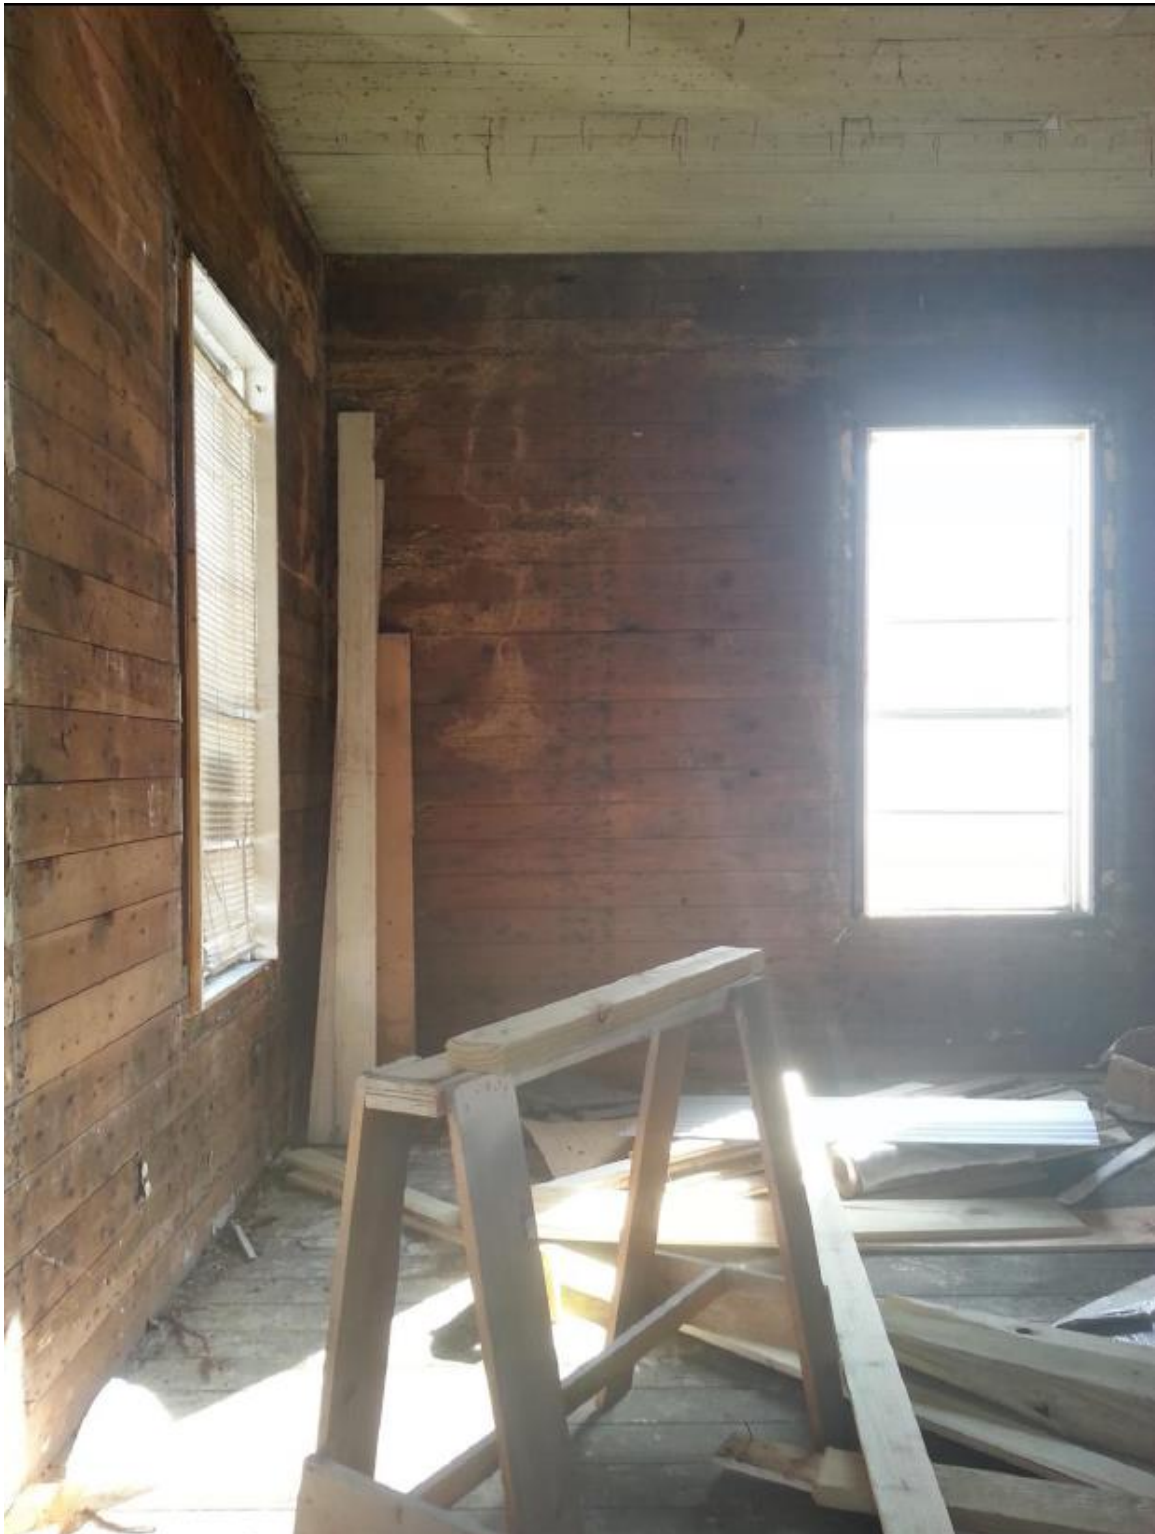
ATTACHMENT A
PREVIOUS COMPLIANCE DOCUMENTATION
STOP WORK INSPECTION 2/18/2015

- On February 9, 2015, the applicant received a Stop Work order for exceeding scope of a previously purchased permit for a residential re-roof; the front porch was removed and rebuilt, new inappropriate columns were installed, and the gable window was removed
